Utility Pole

IR Text Comment	Value
Location	Utility Pole
Equipment	480 Volt Service

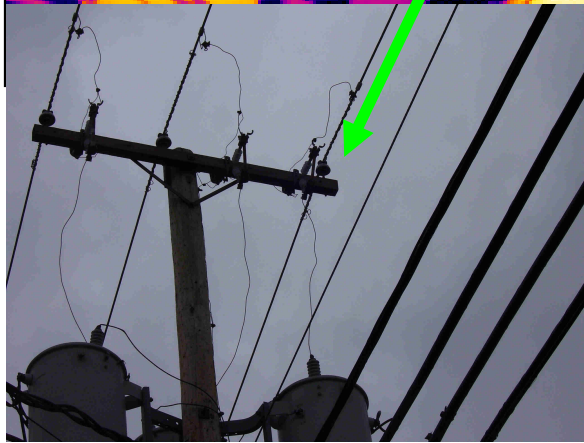
Spot 1	220.8°F	Spot 2	66.2°F	Rise	154.57°F
--------	---------	--------	--------	------	----------

Comments: East phase shows extreme temperature rise on the bottom of the cutout mechanism. Advise utility co. ASAP.
